Mud Plaster Wall Paintings of Bhaja Caves: Composition and Performance Characteristics

Abstract

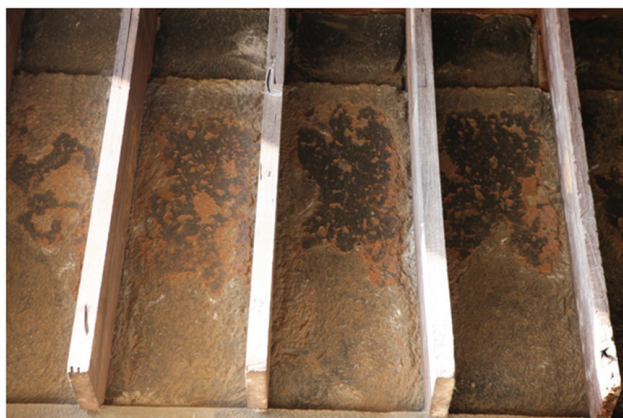
Fig. 3. Photograph showing two layers of mud plaster at Bhaja

at Bhaja (Fig. 3).

There is a coarser lower layer levelling the roughness of the host rock whose thickness depends on the topography of the stone surfaces. The thickness of this layer varies between 15-20 mm in the caves. There is an upper finer layer on top of the inner layer that give base to the painting (layer) with thickness ranging from 10-15 mm at various points. The earthen plaster layers are composed of earth with characteristics very close to soil type available in the surroundings (Tamhane, 1964). In a higher rain fed area of Western Ghats, there is all probability of occurrence of more of a clayey soil for construction work. As local soil is likely to have been exploited for earthen plastering by ancient Indians, there is all probability of higher clay proportions in the mud plaster of Bhaja. The occurrence of 60-80% clay in the surrounding soils has been reported around Bhaja (Website: mpcb.gov.in/relatedtopics/CHAPTER2.pdf). However, in an area of complex geological history, obtaining soil samples of right kind is now a problem especially after the growth of urban localities around ancient structures.

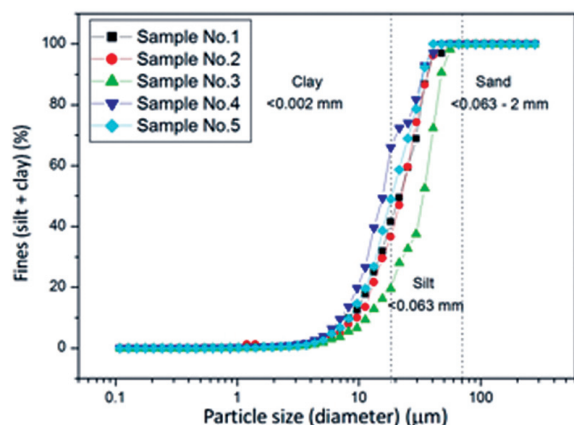
The particle size analysis of earthen plaster of Bhaja provided distribution curve through which the soil was characterised. The type of the earthen support was assessed through the presence of sand, silt and clay in the plaster. As obtaining higher quantity of sample is not possible for the decorative arts of Bhaja, we relied on laser particle size analyser which needs smaller samples and the results are more precise, reliable and faster. The earthen plaster samples no. 1-5 was examined under laser diffraction analysis. Three trials for each measurement were taken and the average reported in the data. The particle size analysis curve of Bhaja plaster is shown in Fig.7.

From the particle size analysis, it is observed that the earthen plaster of Bhaja is much finer and contains far less silt size particles. The grain size analysis showed the majority of grains

Fig. 7. The particle size analysis curve of Bhaja plaster.

are of clay sized (more than 65%), followed by sand sized (20-28%) and least the silt sized (7-15%). Due to presence of more proportion of clay size particle, the earthen plaster of Bhaja shows compactness. The compactness of the earthen plaster was further improved by addition of slaked lime, iron oxide etc. into the plaster. However, the particle size distribution of soil structure precisely influences humidity transfer within the plaster (Katheen, 1997). The higher
